ZX Spectrum Lower RAM Replacement Module V1.3 For Issue 2 - 6 PCBs

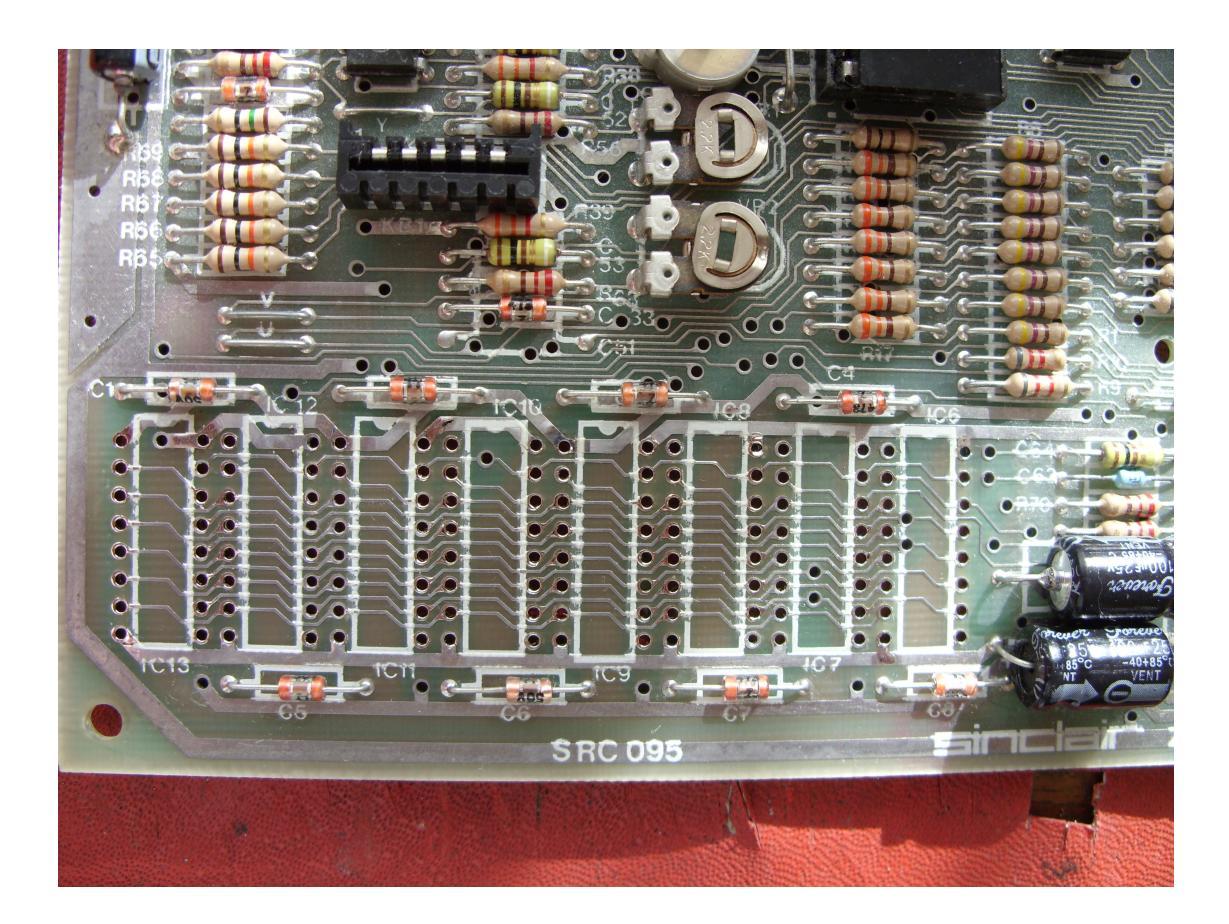
Spectrum PCB with lower RAM chips removed and cleaned.

Usually the Spectrum's lower RAM chips are soldered onto its PCB (IC6-IC13) All eight will need to be removed to fit the RAM board. The easiest way to do this is it to clip their legs near the chips' bodies with some fine-point cutters. The leg stubs can then be plucked out using soldering iron and tweezers. The area and pads should be tidied up with a flux pen and solder wick, and finally cleaned with isopropyl alcohol. Inspect both sides under a magnifying glass for shorts due to solder splashes etc.

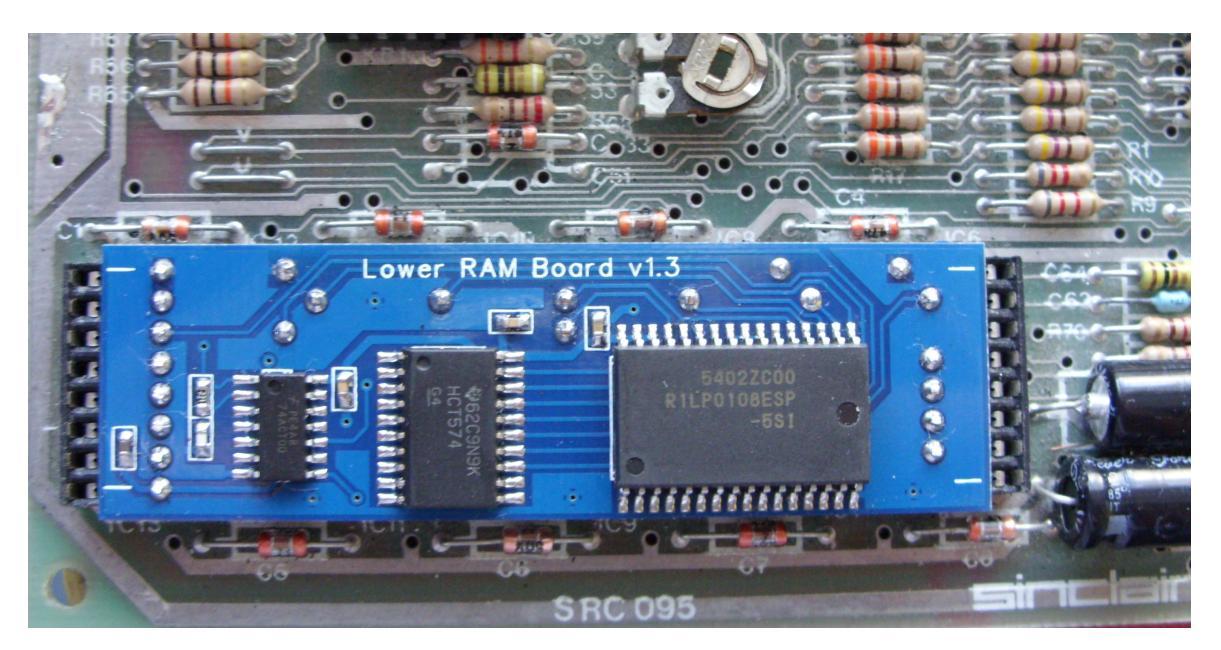
Module correctly located between first and last columns of socket holes. (Note the "-" marks on the module aligning with top/bottom pins)

At this point you can either solder some DIL sockets (not "turned pin" types) where the chips were and press the RAM board into them, or the module can be soldered directly onto the Spectrum PCB. The v1.3 module fits between the first and last columns of holes (ie: the holes for pins 1-8 of IC13 and pins 9-16 of IC6 should still be visible when the module is located - see photo on the following page). If you need to, you can remove capacitors C1-C8 as they are not needed when the old chips have been removed. Take care if soldering the board in place that the module's pins do not drop through should the solder melt on the top side.
